ENGINEERING PROJECTS:PROGRESS REPORT

Hurricane Matthew Recovery Project

Cross Creek Bank Stabilization at Lamon Street

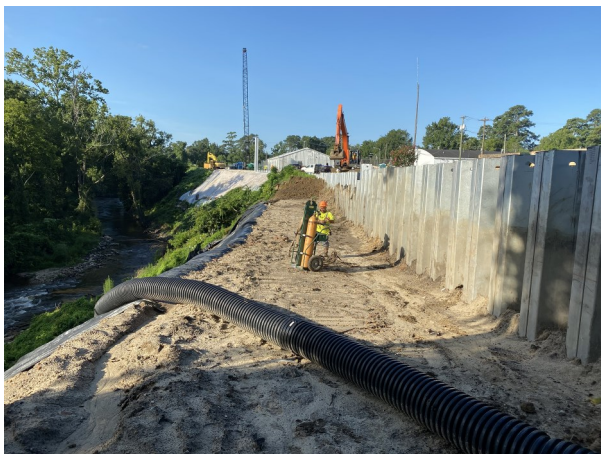
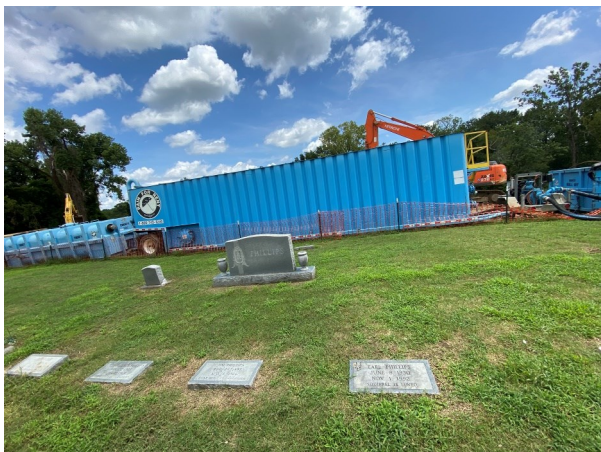
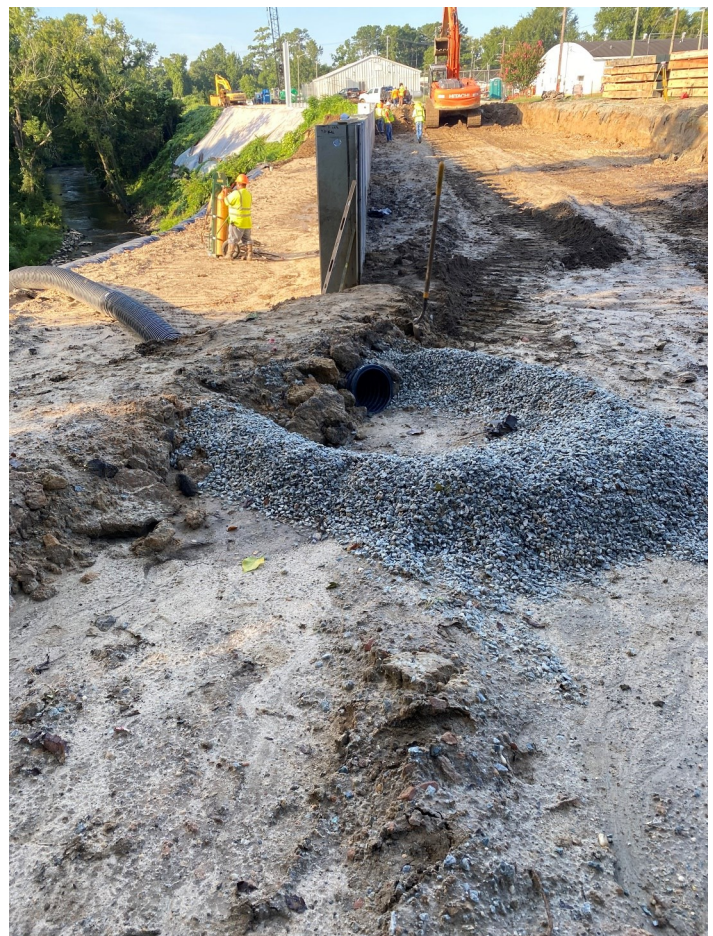
The contractor continued driving piles from Station 1+25 working towards Station 0+00 and started cutting sheet piles to specified height. Contractor continued pre-activity discussions related to whaler and tie-back system, testing procedures and also started excavating earth in efforts to support tie-back operations. They installed surface water control measures and received water supply measures.
